# INVESTIGATION OF SA-501 S-IVB AUXILIARY PROPULSION SYSTEM FLIGHT ANOMALIES

*by K. Coates and E. Donald*

*George C. Marshall Space Flight Center  
Marshall, Ala.*

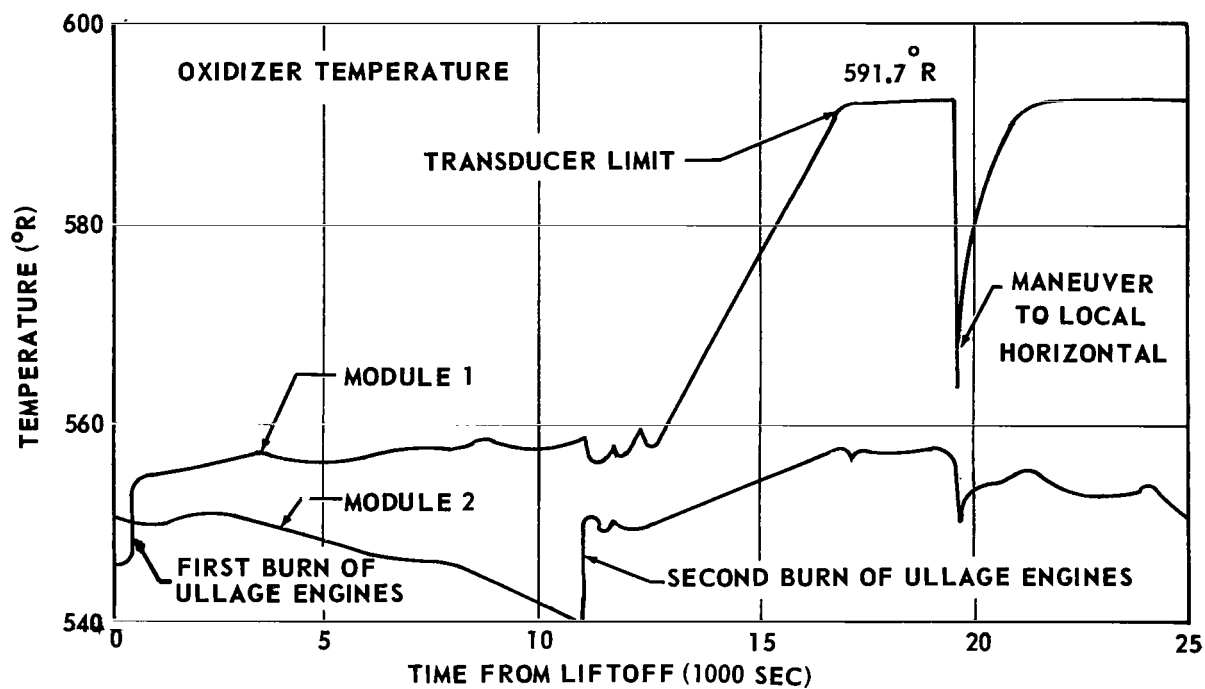
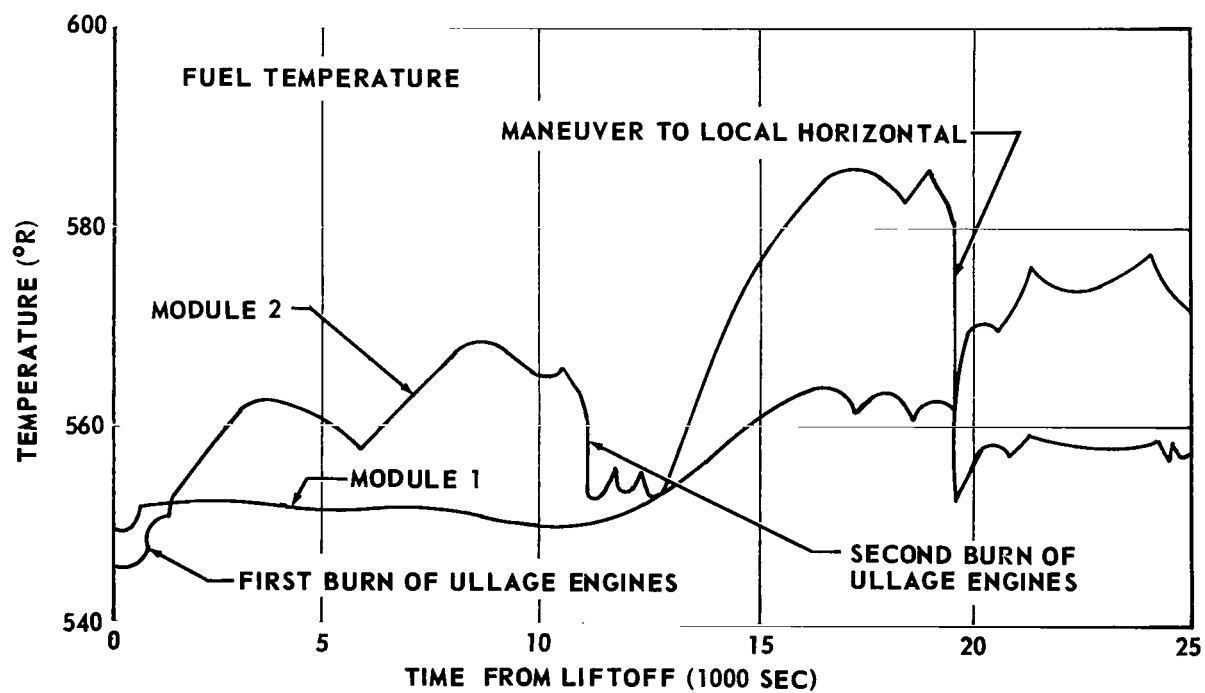
FIGURE 4. PROPELLANT TEMPERATURE

The design of the APS is intended to maintain the propellant temperatures within acceptable limits by means of passive control. This is done by means of thermal insulators placed in conduction paths to critical components, by insulation placed around propellant tanks, by polishing of propellant lines, and by painting the surface of the module with a thermal reflective paint which keeps the absorbtivity to emissivity ratio  $\frac{\alpha}{\epsilon}$  to 1.0. According to McDonnell Douglas Corporation (MDC) personnel, the effectivity of this coating appeared to be degraded (from the anticipated values) during the earth orbital operation. During development testing, the APS was subjected to extensive thermal environmental testing in the MDC high vacuum facility at Huntington Beach. The module was subjected to both hot and cold temperature cycling with a normal surface coating and with a black surface. No problems were experienced. The temperatures in flight could have resulted from one or a combination of the following:

After examining each of the possible causes, the most logical explanation for the anomaly is a combination of (3) and (4). Heat transfer calculations by MDC and an examination of the flight data do indicate a degradation of surface properties in earth orbit. Since the Saturn I-B modules have been repainted in the past before flight and the surface coating did not deteriorate, cause (1) must be eliminated. Cause (2) can also be eliminated because of similarity to Saturn I-B, and the fact that the most severe degradation of the paint, if caused by boost heating, would have occurred on the nose of the module with very little heating on the aft end. The heating caused by orientation of the aft ends of modules towards the sun indicates just the opposite effect. Thus the combination of (3) and (4) represents the most probable cause of the anomaly.

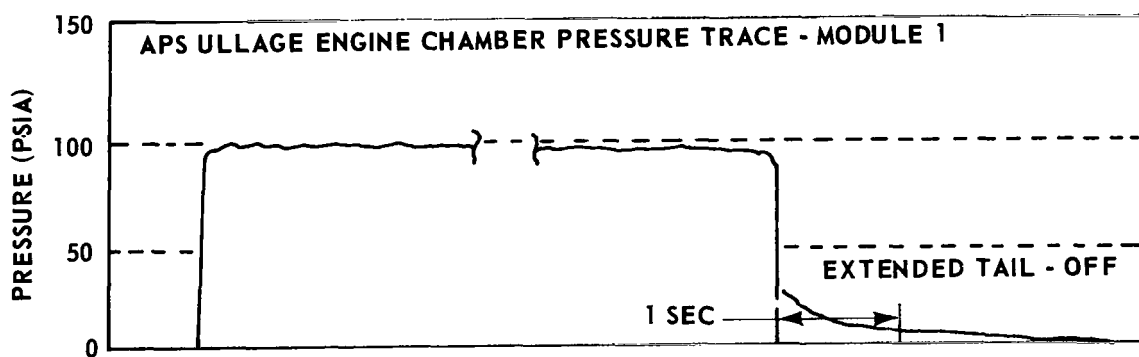
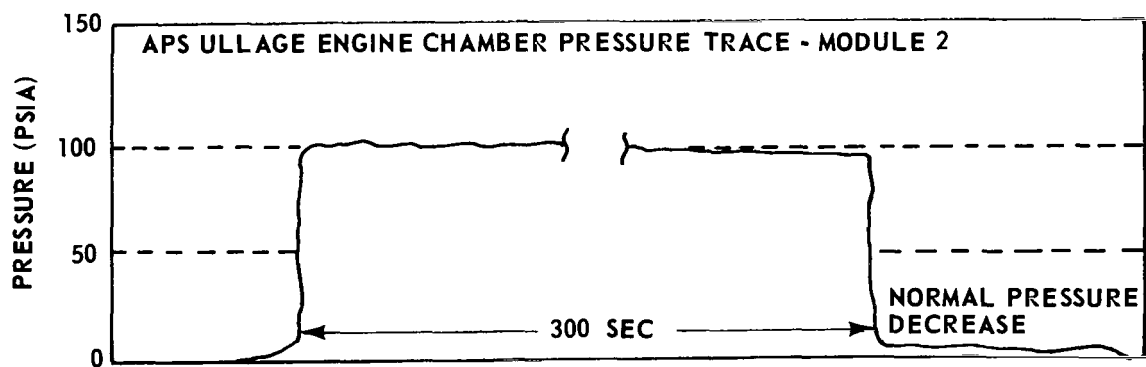
FIGURE 5. ULLAGE ENGINE  $P_c$  TRACE

Engine 4 of module 1 exhibited a slower than nominal Pc tailoff for each firing (Fig. 5). The specification requires that the thrust level shall decay from the full value to 10 percent value within 35 m/sec from cutoff signal. This value is based upon the close-coupled transducer used for engine manufacture testing and with no surge suppression circuitry.

As shown in Figure 5, the pressure decay for engine 4 of module 1 was slower than specification limits. The data received represents the first flight environment chamber pressure data ever received for this engine. The decay characteristics are a function of the distance of the pressure detection device from the source of the pressure and the size and volume of line leading to the pressure transducer. The amount of time for decay of the engine from cutoff to 10 percent  $P_c$  was less than 1 second. The cutoff characteristic for the engine was repeatable for both starts in space, and appears to be similar in

time to the tailoff in the sea level burp firings. The data were discussed with Rocketdyne (engine vendor) and their opinion was that the engine performed satisfactorily and such traces had been noted in some of their sea level testing. However, the flight trace was different from that nominally expected. Possible causes for the slow tailoff would be:

Several other possible causes, such as valve seat swelling, were examined and eliminated. The most probable cause was determined to be a slight contamination (which was imbedded in the teflon) on the valve seat. The uniqueness and minor effect of the anomaly does not indicate that any kind of serious problem exists, or that it should warrant any further study.

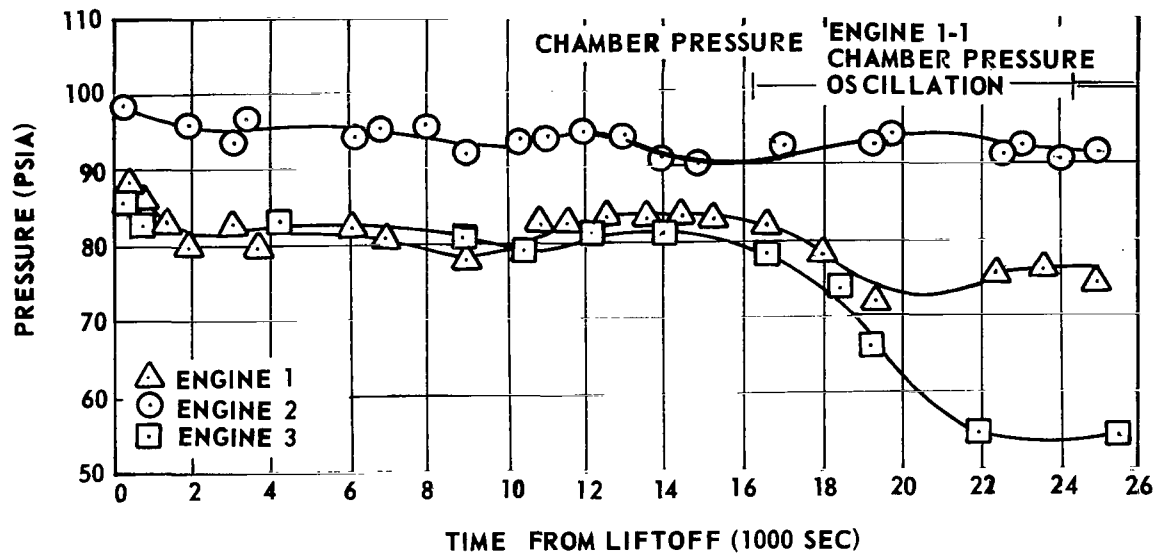
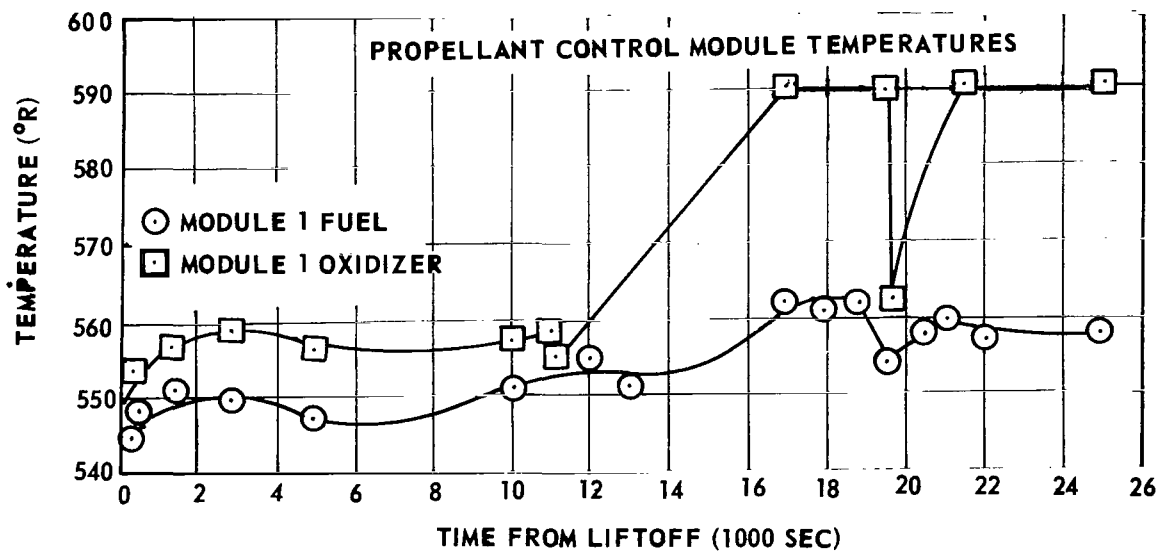
FIGURE 6. ENGINE CHAMBER PRESSURE/TEMPERATURE TRACE

The decay in chamber pressure of engines 1 and 3 of module 1 occurred during the period of high propellant temperatures ( Fig. 6). The high propellant temperature was the obvious suspect after reviewing the data and noting the correlation between the chamber pressure decay and oxidizer temperature rise. The result of high engine injector and oxidizer temperature and normal manifold pressure oscillations would be a reduction of flow caused by vaporization of the propellant in the feed system. This was determined to be the cause of the anomaly, and the test section will cover the results of the MSFC tests to verify the cause of the anomaly.

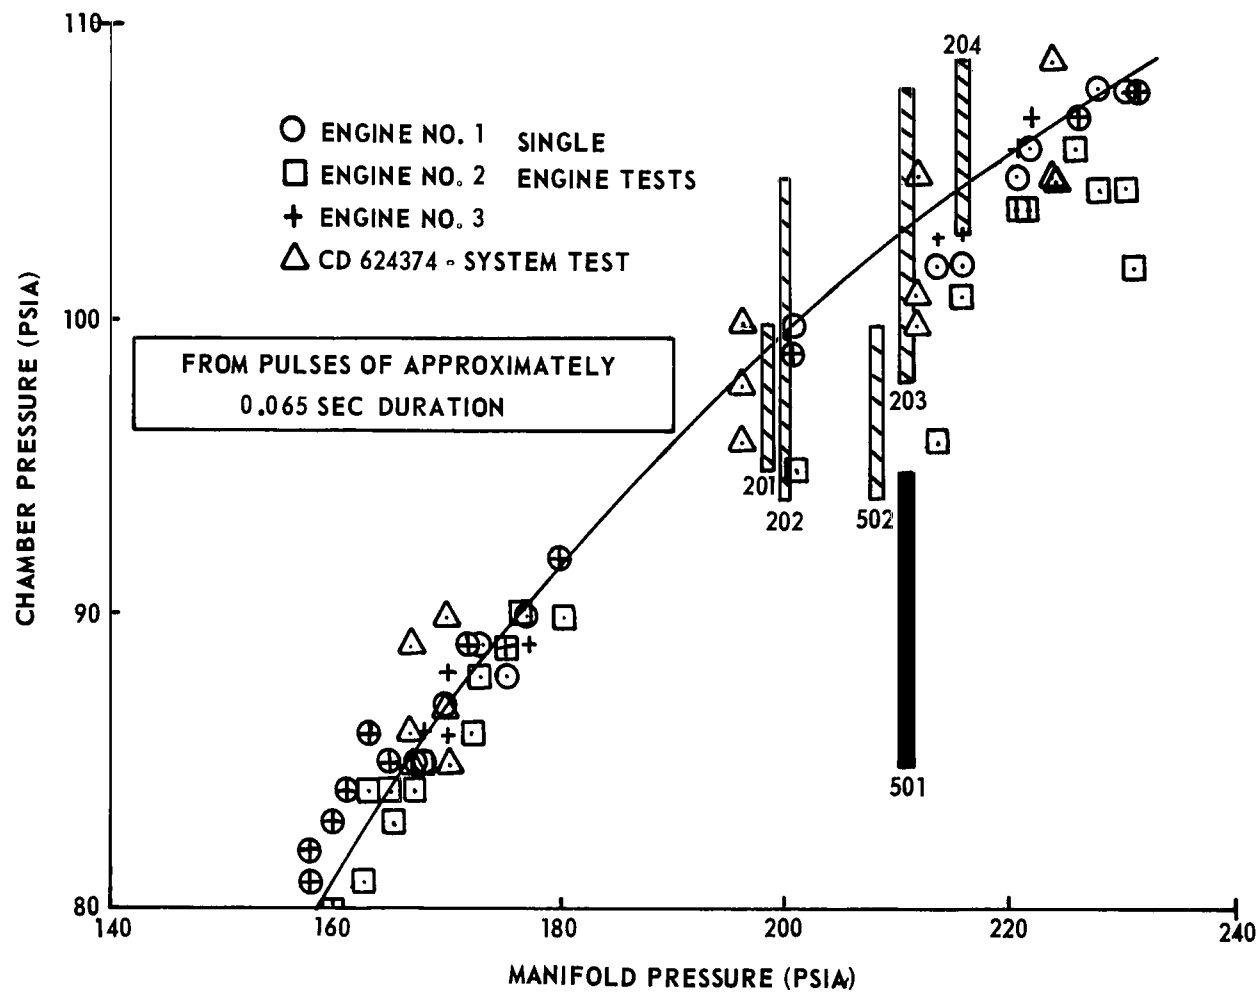
FIGURE 7. COMPARISON OF TEST AND FLIGHT ENGINE CHAMBER PRESSURE

Degraded performance was noted in engines 1 and 3 of module 1 and engines 1 and 2 of module 2. Four engines were approximately 10 to 15 percent low in  $P_c$  near the beginning of APS operation and continued at those levels or lower throughout the mission. The remaining two attitude control engines that were 5 percent low in  $P_c$  would not normally be considered an anomaly since instrumentation, engine tolerance, etc. , would allow for this. However, for this mission, the low  $P_c$  values may indicate a trend. A comparison of test and flight engine chamber pressure is shown in Figure 7.
